Manhole Inspection Summary

Manhole # S39A__049MH

Insp Date: **11/29/07 8:45 AM**

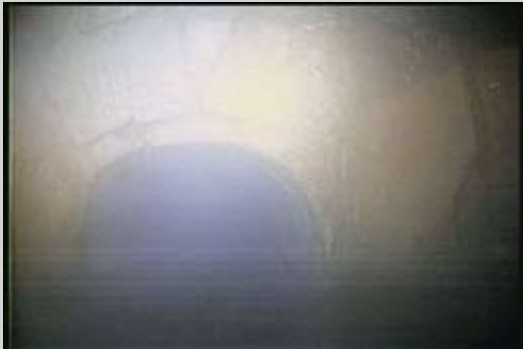
12 O'Clock Outflow

8 in. Circular Gravity Sewer
Pipe Out @ 12 O'Clock

Pipe Material: **Clay** ☐ Pipe Lined

Infiltration: **None** Pipe Seal Cond: **Unknown**
